10/11/2004

Scaffold Clamp Safety Alert

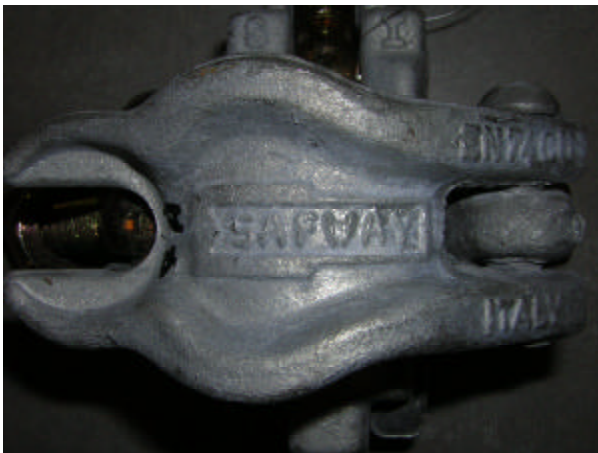
Photo 1

- a) The caps are shaped like a clamshell and bear impression stamps showing the words “SAFWAY” and “ITALY” (See Photo 1.)
- b) The undersides of the caps DO NOT have the two indentations shown in Photo 2.

Top Side of Cap "Safway" and "Italy"

The manufacturer of the affected clamps, working through Safway, is offering to replace them. Safway is in the process of notifying each of its customers that may have received these clamps, which can be identified as follows:

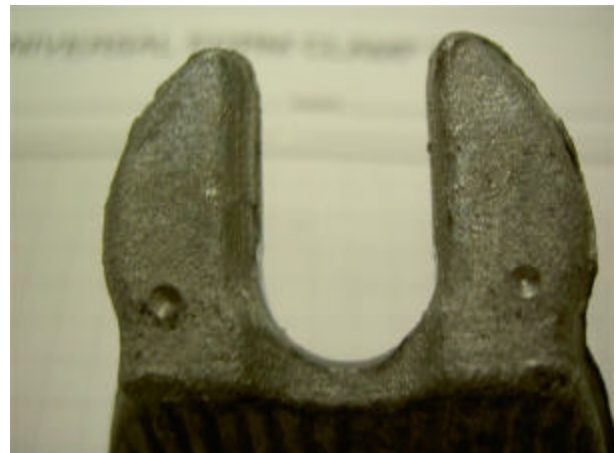
Photo 2

Underside of cap showing two indentations.
